Rumpke Landfill Odor Information – Update

Odors from Rumpke Sanitary Landfill may be caused by gas, garbage or a combination. Southwest Ohio Air Quality Agency is working with Ohio EPA, U.S. EPA, Hamilton County Public Health, Colerain Township, Metropolitan Sewer District (MSD) and Rumpke to protect human health and reduce odor issues at Rumpke Landfill in Colerain Township.

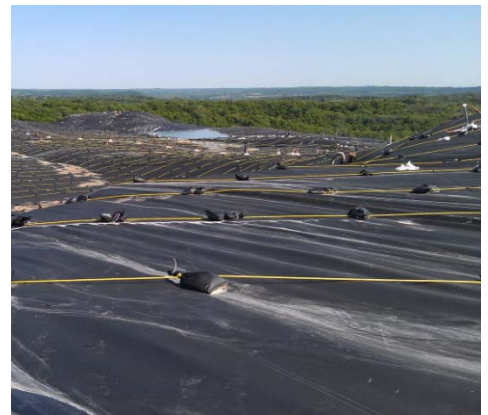
In an effort to control increased odors, Rumpke installed a covering called an Odor Control Blanket (OCB) – which is intended to trap and contain odors – over the affected area at the north end of the landfill.

A total of 56 acres of OCB cover the reaction area. A portion of the OCB can be seen from U.S. 27 in Colerain Township. Since 2013, Rumpke has installed approximately 32 acres of a new OCB that contains a plastic barrier layer. This plastic film helps reduce the amount of gas escaping through the blanket. This new OCB is installed on top of the existing OCB. Rumpke personnel continuously inspect the OCB for tears and makes repairs to help reduce odors.

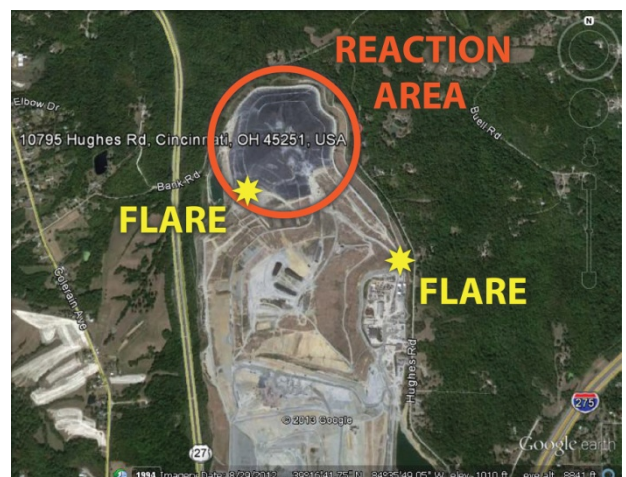
Utility Flare

The utility flares are used to burn lower methane gas from the reaction area to assist with odor control. In January 2013, Rumpke moved the two utility flares from a side-by-side location to help achieve better gas collection from the reaction area. There is now a flare located on the eastern side of the reaction area and the other is on the western side of the landfill.
