Rumpke Landfill Odor Information – Update

Odors from Rumpke Sanitary Landfill may be caused by gas, garbage or a combination. Southwest Ohio Air Quality Agency is working with Ohio EPA, U.S. EPA, Hamilton County Public Health, Colerain Township, Metropolitan Sewer District (MSD) and Rumpke to protect human health and reduce odor issues at Rumpke Landfill in Colerain Township.

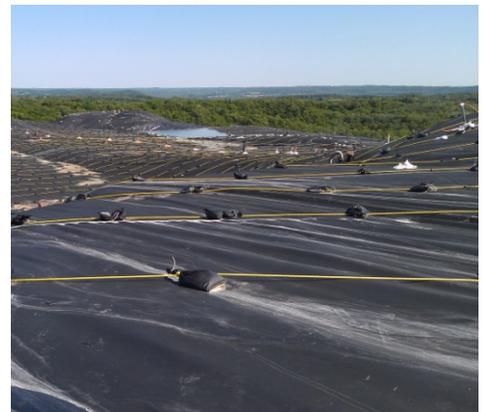
In an effort to control increased odors, Rumpke installed a covering called an Odor Control Blanket (OCB) – which is intended to trap and contain odors – over the affected area at the north end of the landfill.

A total of 56 acres of OCB cover the reaction area. A portion of the OCB can be seen from U.S. 27 in Colerain Township. Since 2013, Rumpke has installed a new OCB that contains a plastic barrier layer. This plastic film helps reduce the amount of gas escaping through the blanket. This new OCB is installed on top of the existing OCB. Rumpke personnel continuously inspect the OCB for tears and makes repairs to help reduce odors.
